Way We Were

The Cable Broke

David Nicholas & Steve Leatham, Researchers

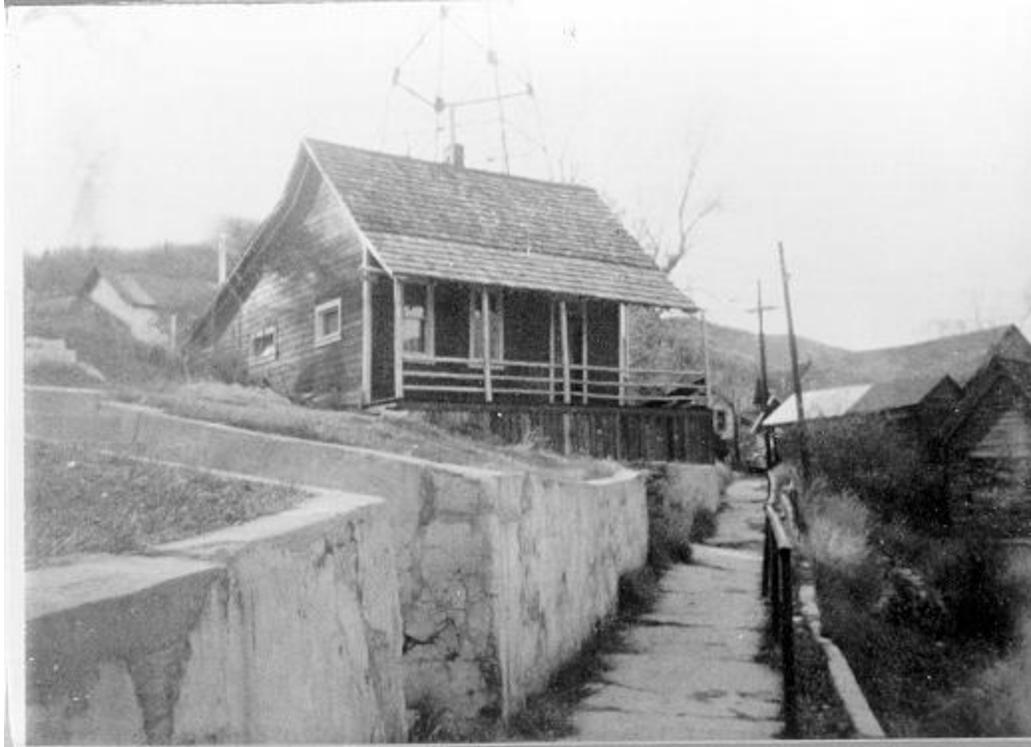
Image ID: 1987.3.119

Caption: The late historian Gary Kimball lived at 655 Woodside Avenue, pictured. One of the towers that made up the Silver King aerial tramway system stands right behind the house.

Besides damaging the buckets and cable, one of the smaller towers at the upper end of the line was torn down and considerable injury was done to the tramway machinery at the mine. The distorted leg of the 4" x 4" angle iron tower next to the Kimball home serves as a stunning reminder of the extreme force generated by the accident.
